TS-AMD-85741
October 1985

HISTORICAL AERIAL PHOTOGRAPHIC ANALYSIS OF WOOD TREATMENT FACILITIES

Montana

W. M. Mack
Environmental Programs
Lockheed Engineering and Management Services Company, Inc.
Las Vegas, Nevada 89114

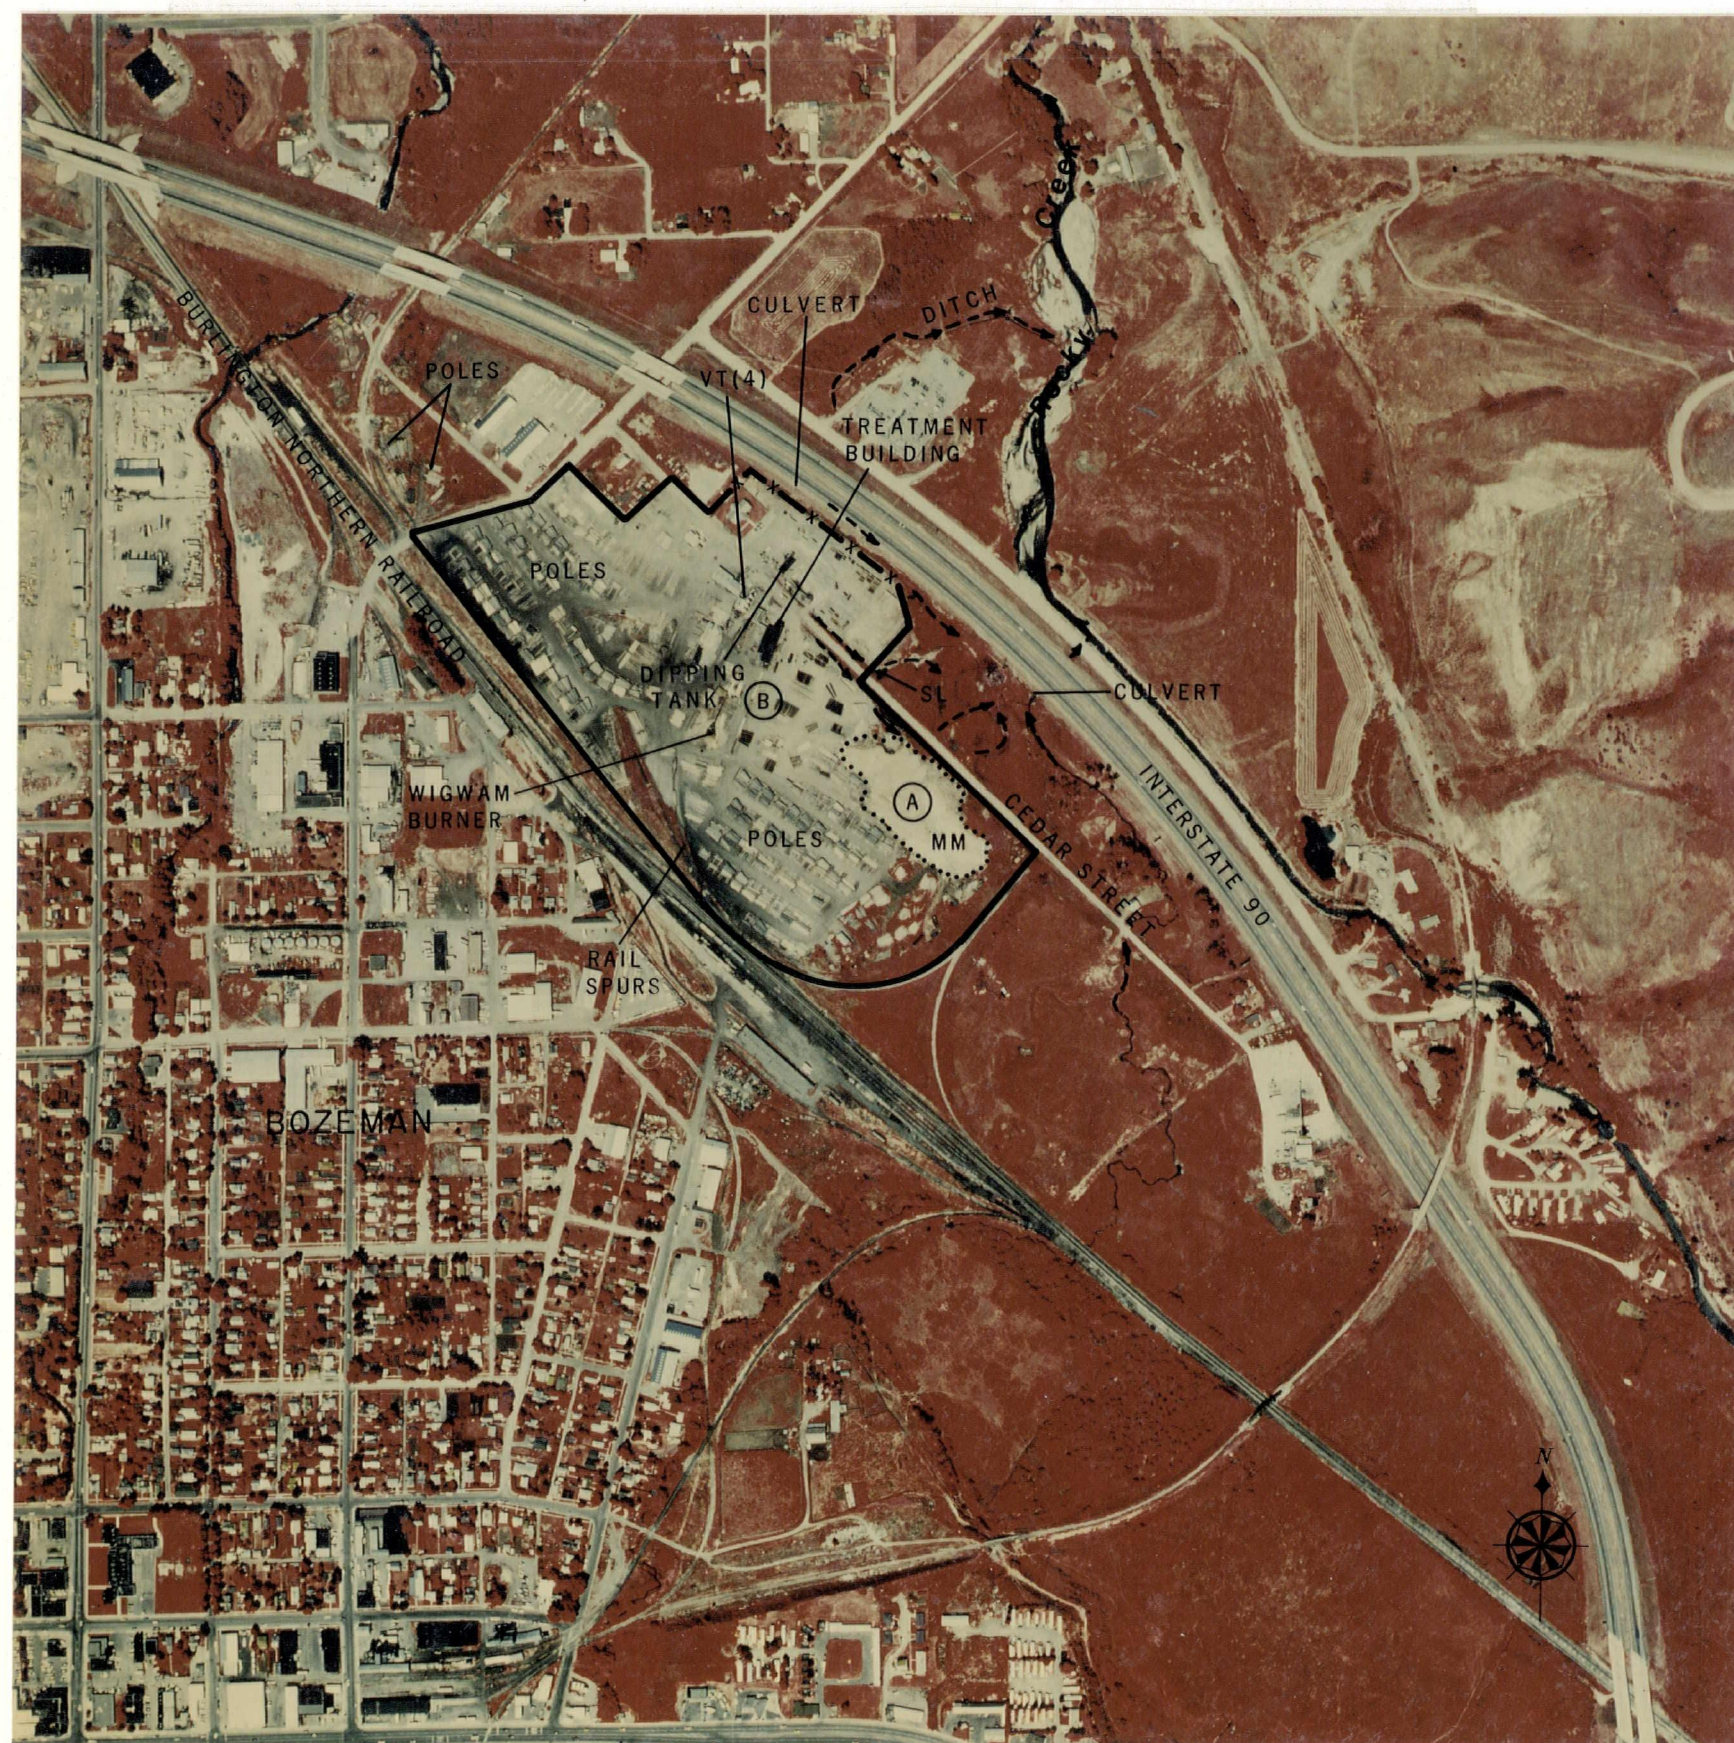
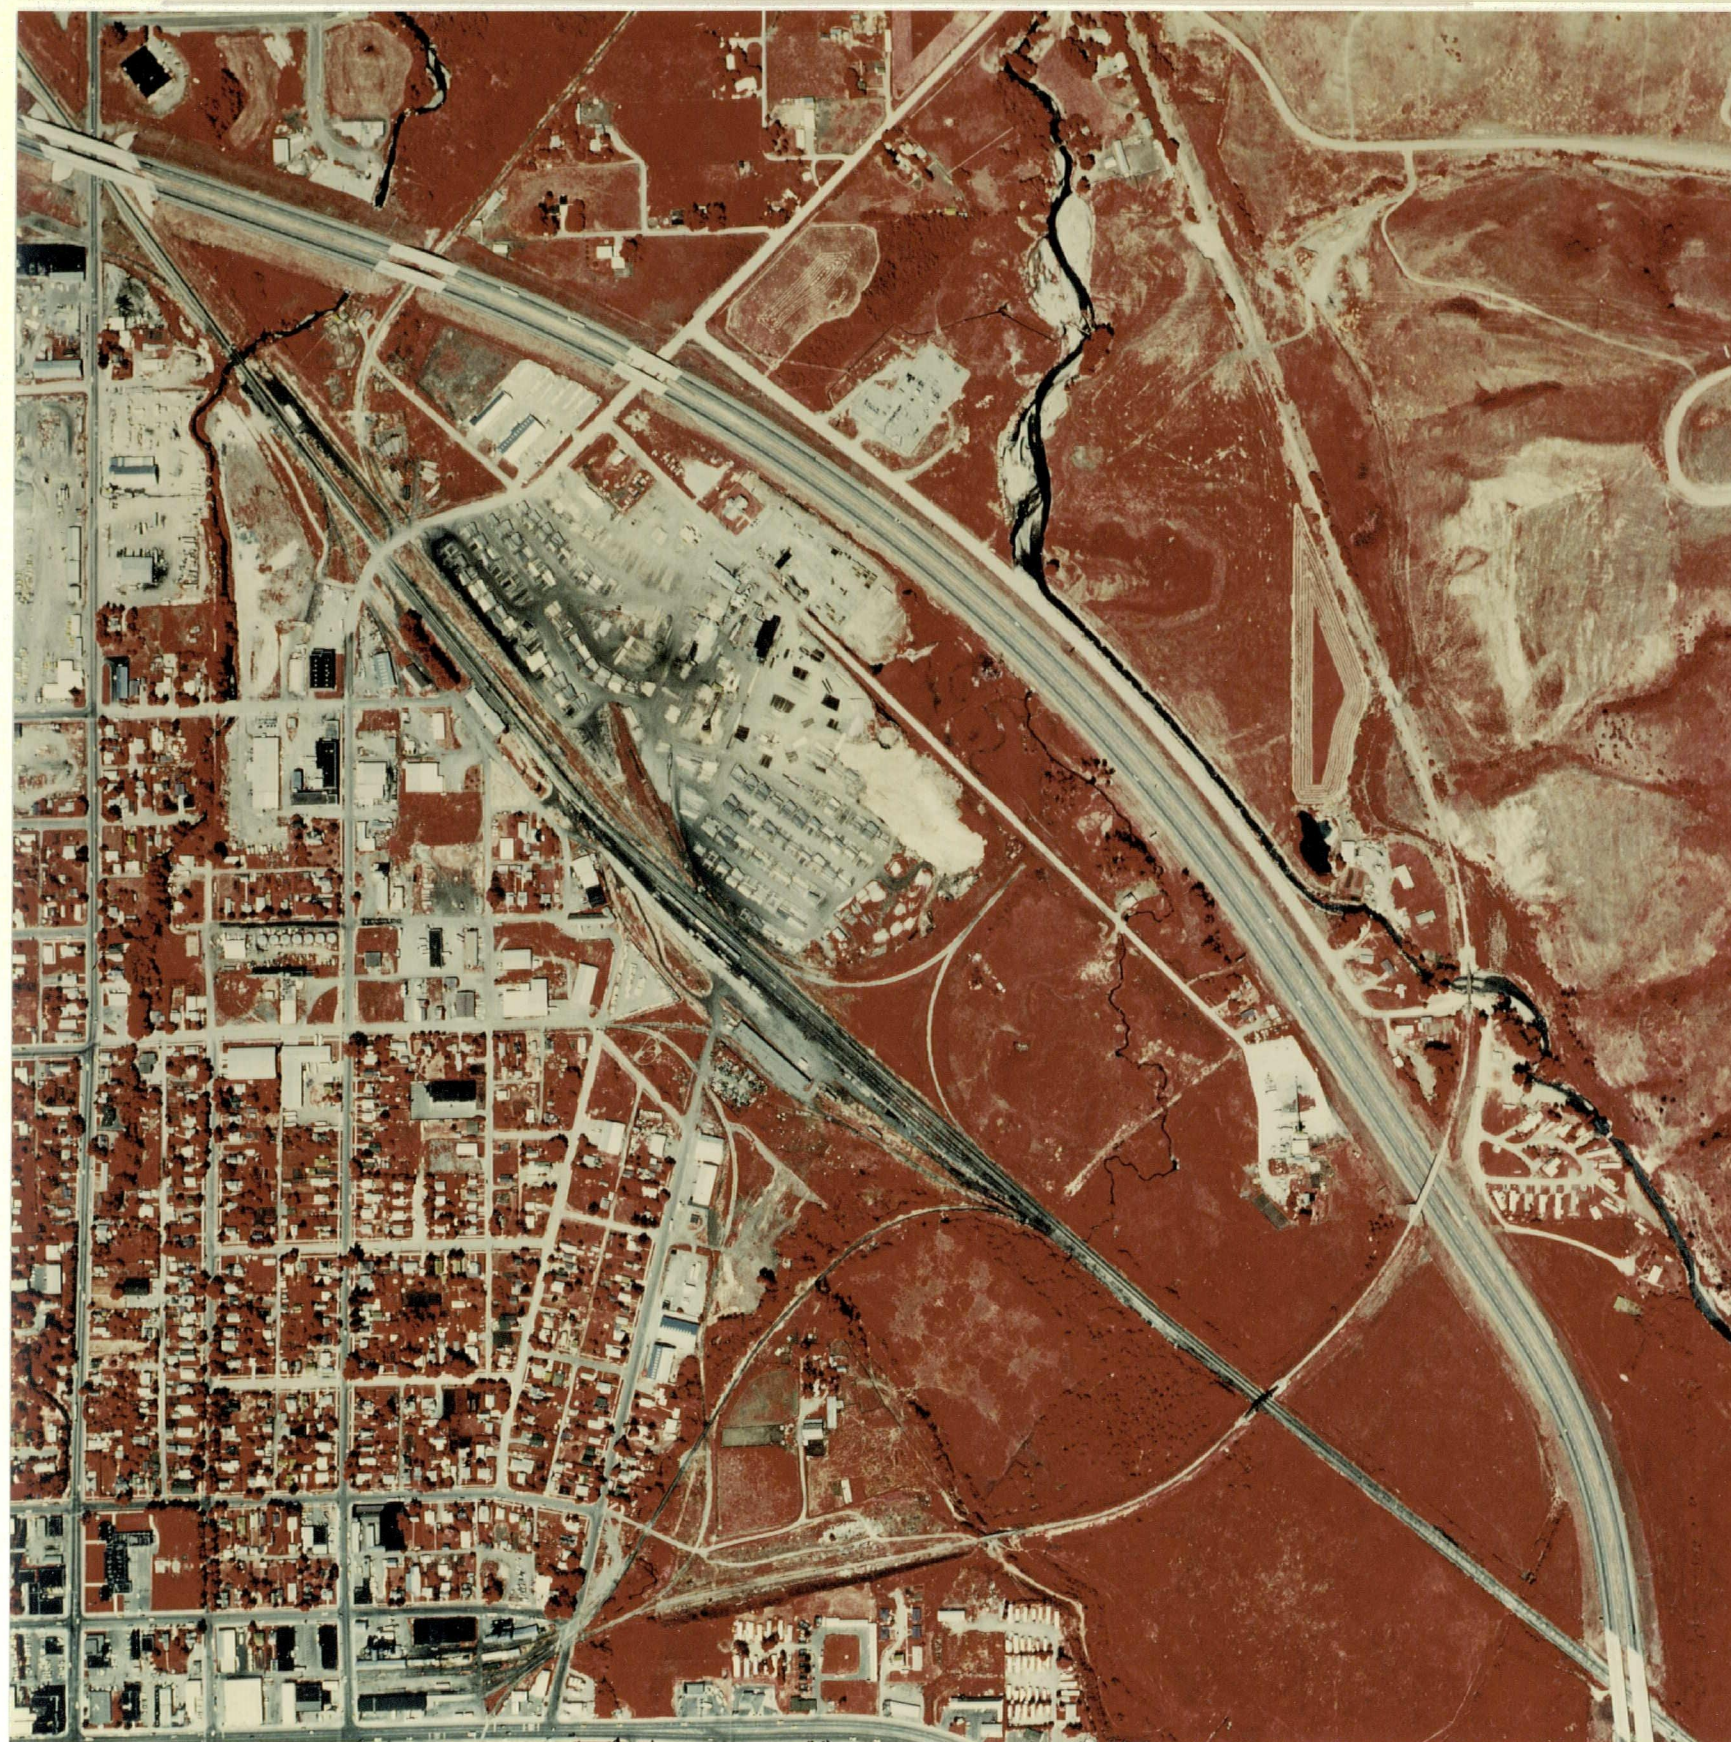
Figure 13. Idaho Pole Company, July 16, 1981. Approximate scale 1:8,000.

Sawdust, wood chips, and wood wastes are dumped in the east portion of the site where a mound of this material has accumulated (annotation "A"). This dumping of waste has filled the terrain depression in this area that had contained standing liquid on the 1965 photograph (Figure 12, annotation "A").

Surface runoff from the site flows northeast to a culvert under the Interstate Route 90 that empties into the natural drainage system and Rocky Creek.

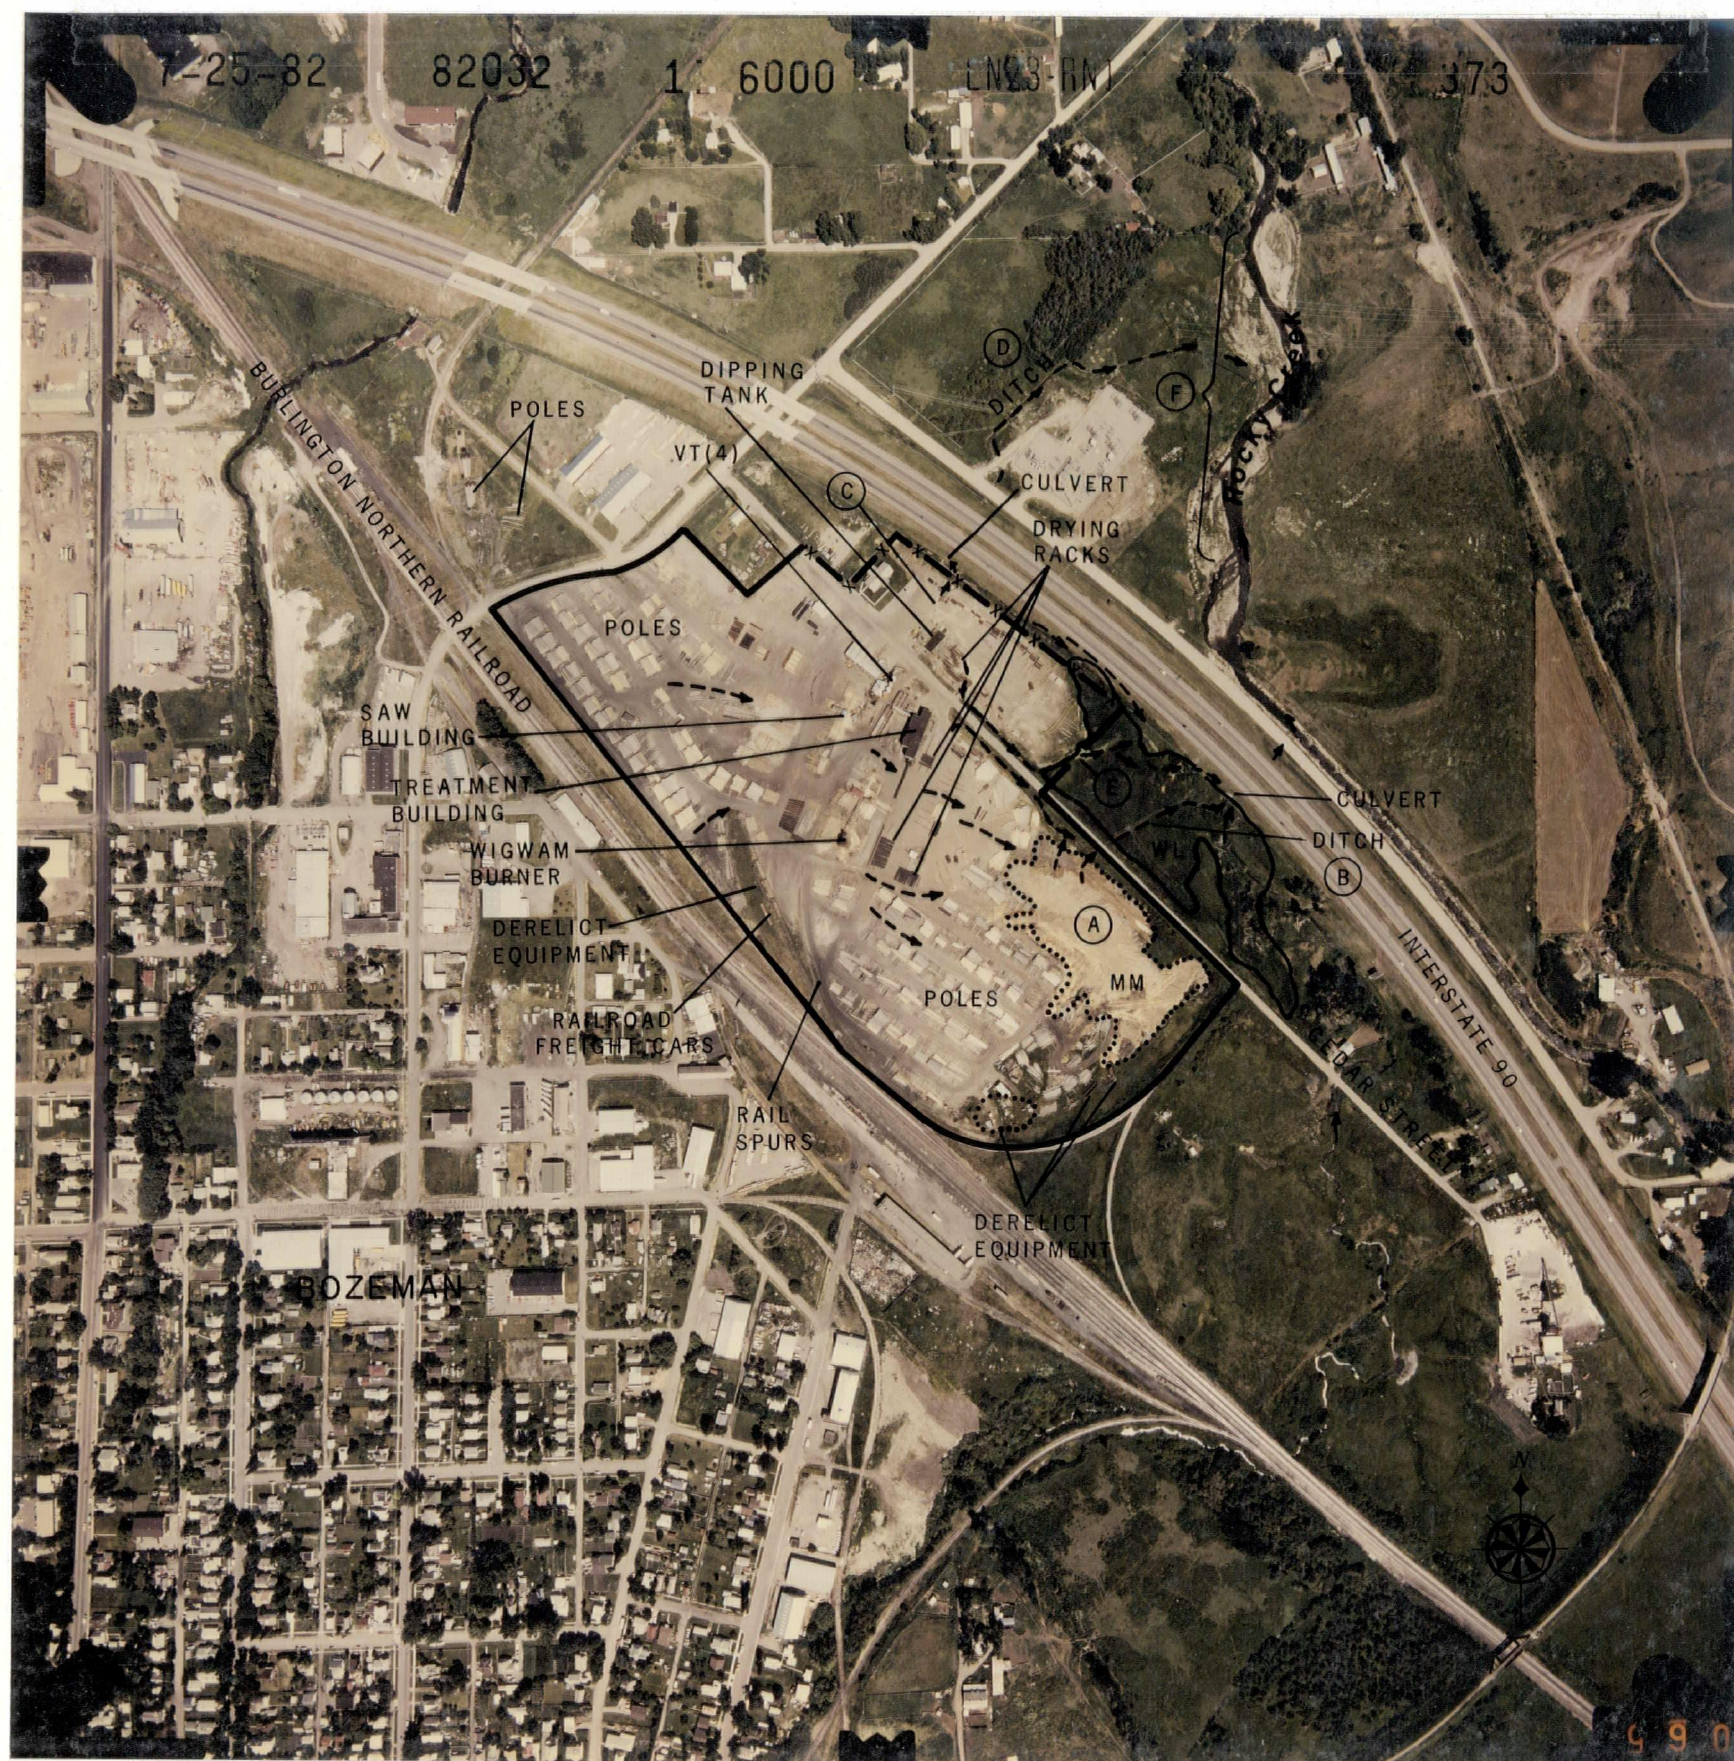
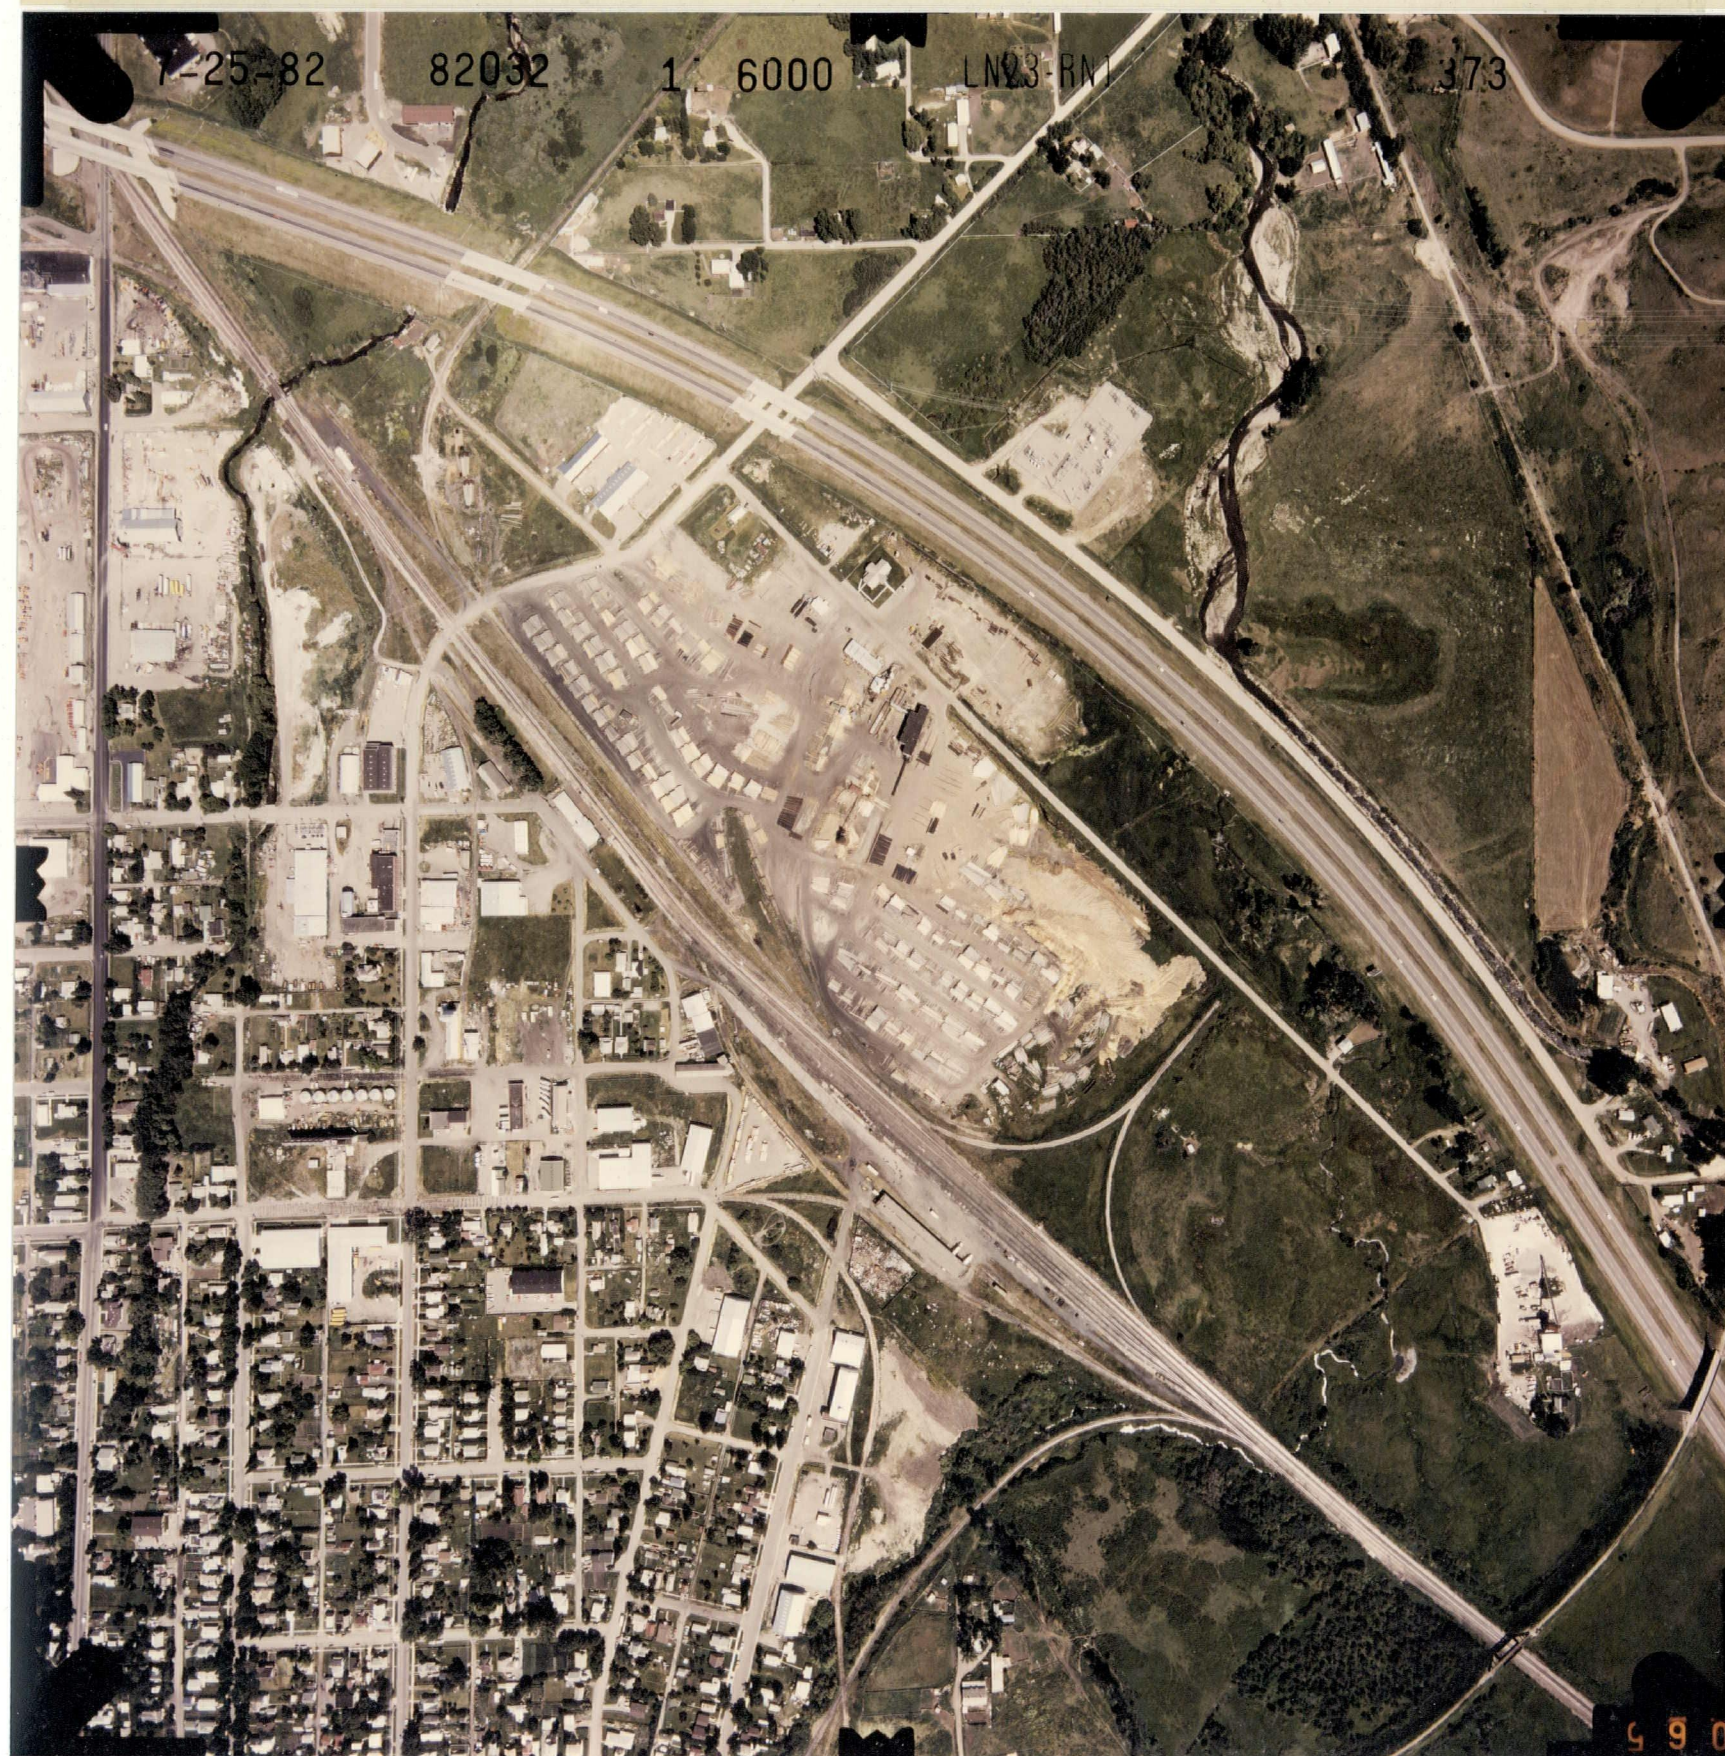
Figure 14. Idaho Pole Company, July 25, 1982. Approximate scale 1:6,000.

Liquid is also visible draining away from the treated poles as they are stacked out to dry on the south side of this dipping tank. Surface runoff from these drying poles drains eastward, leaves the facility via ditches (annotations "B" and "E"), and eventually reaches Rocky Creek. It is likely that rainwater runoff leaving the site could transport contaminants from the stacks of treated wood poles into the natural drainage system, specifically Rocky Creek.

The vegetation (annotation "F") along Rocky Creek on the north side of Interstate Route 90, downstream from the study site, appears spotty compared to the 1965 photograph (Figure 12). This reduction in vegetation probably results from stream scouring due to channelization of this waterway.
